Glenoid Component Failure in Total Shoulder Arthroplasty

CURRENT CONCEPTS REVIEW

By Frederick A. Matsen III, MD, Jeremiah Clinton, MD, Joseph Lynch, MD,
Alexander Bertelsen, PA, and Michael L. Richardson, MD

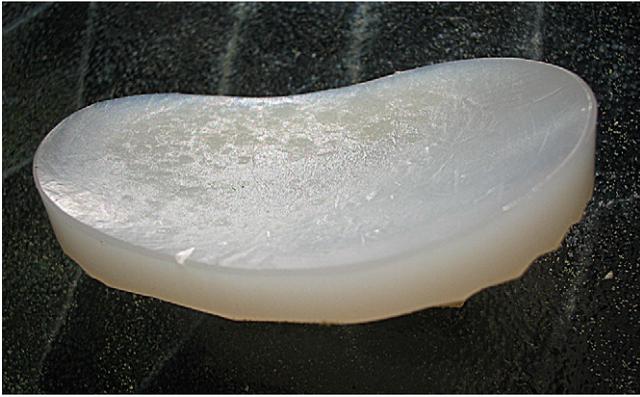
Fig. 1
Pitting and erosive wear of the posterosuperior aspect of a retrieved glenoid component that had been inserted in combination with a humeral head with a 6-mm-smaller diameter of curvature, as recommended by the manufacturer. The wear resulted in a secondary concavity of the posterosuperior articular surface with a diameter conforming to that of the humeral component. While not shown in this photograph, the keel of this prosthesis had fractured from fatigue.

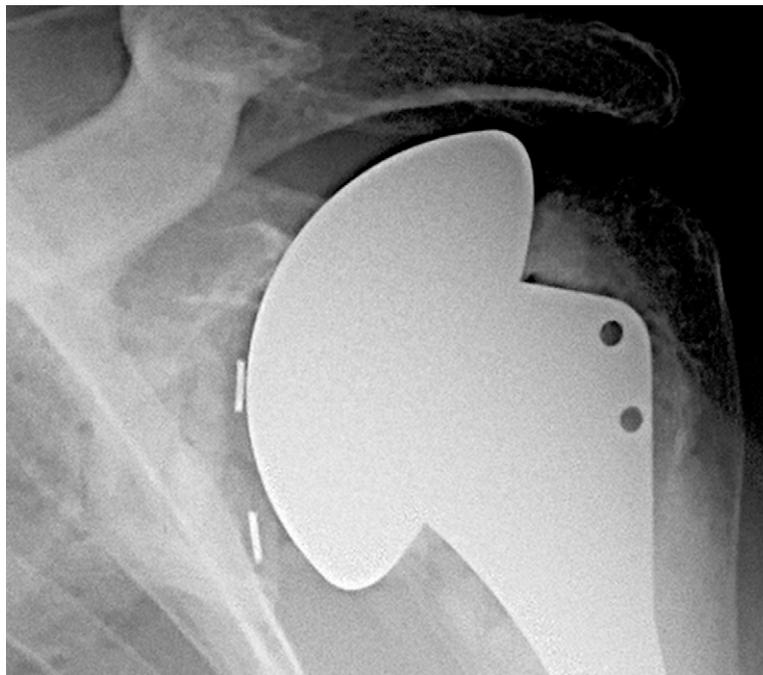
Fig. 2
Thinning of polyethylene at the superior aspect of the component as evidenced by narrowing of the distance between the humeral head and the upper metal marker in the glenoid component in comparison with the distance between the humeral head and the lower metal marker in the glenoid component. The loss of the concavity of the superior aspect of the glenoid component is accompanied by upward migration of the humeral prosthesis relative to the glenoid prosthesis.

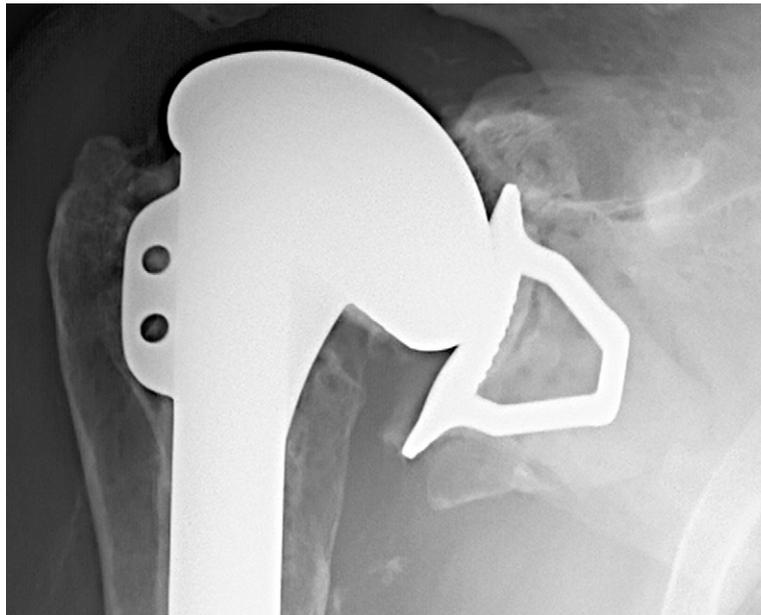
Fig. 3

Complete wearing through of the upper polyethylene of a metal-backed component manifested by the absence of any radiographic clear space between the humeral prosthesis and the metal backing. The wear is accompanied by superior migration of the humeral component and so-called rocking-horse loosening of the glenoid component—i.e., loosening resulting from loading of one edge of the component causing lifting of the opposite edge of the component away from the bone. Note also the large amount of cement that had been used for fixation of the glenoid component and the radiolucent line surrounding the cement.

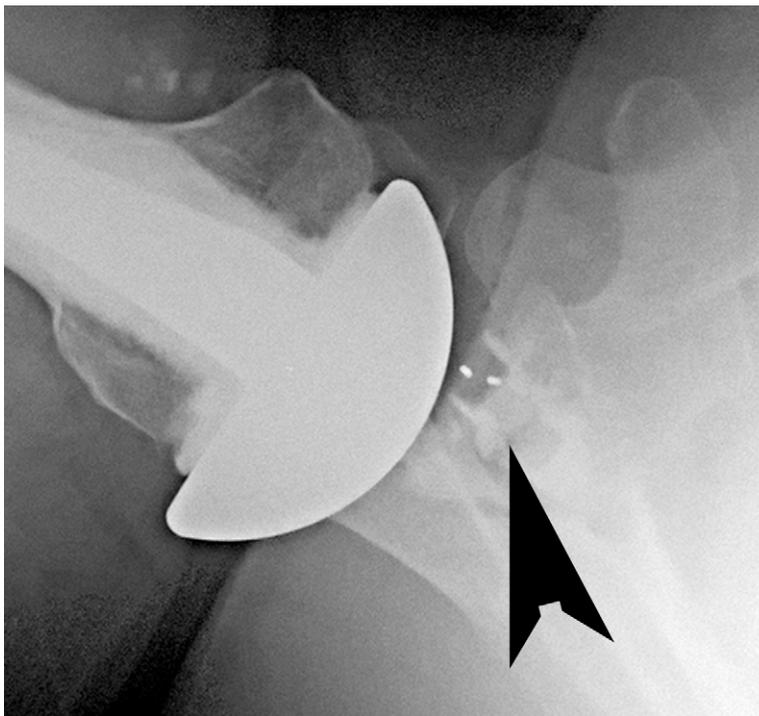
Fig. 4
Radiograph of a failed glenoid prosthesis, showing posterior subluxation of the humerus, eccentric glenoid loading, and posterior wear of the component rim. The keel of the glenoid component and the surrounding cement are fractured (arrow).

screws used for fixation^{16,25}. Catastrophic failure of polyethylene has been a particular problem when the polyethylene was sterilized by radiation in air, giving rise to free radicals that contributed to progressive oxidative deterioration of the components while they were on the storage shelf and after implantation²⁸. Fatigue failure of polyethylene or metal is a risk if the component is loaded with insufficient bone support¹⁶ (Fig. 4).

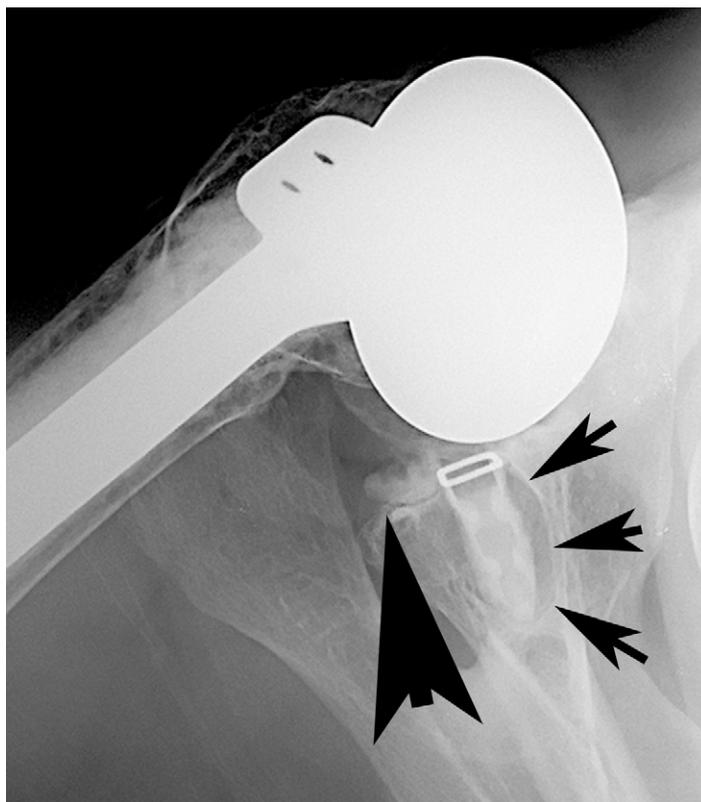
Fig. 5
Lifting up of the posterior aspect of a glenoid component (large arrow) associated with loading of the anterior aspect of the component. This rocking-horse wobbling is associated with resorption of bone around the component keel (small arrows).

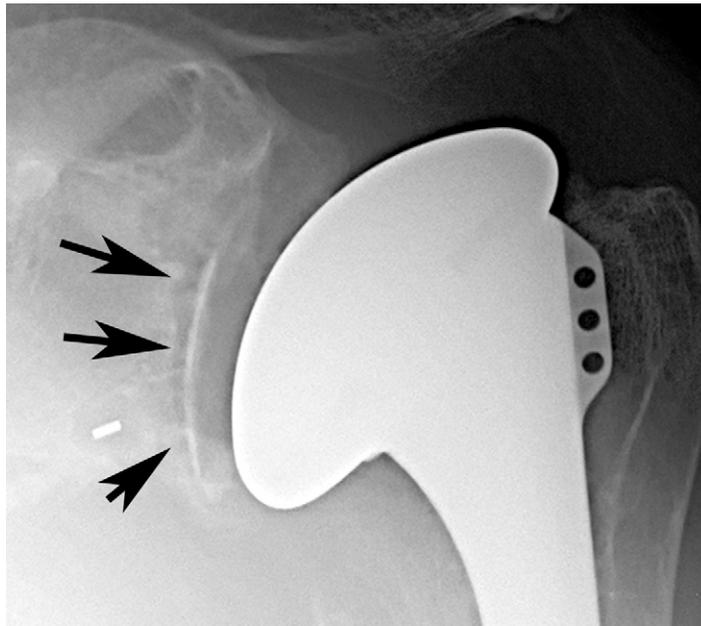
Fig. 6

A loose glenoid component with bone loss beneath a thin layer of cement underlying the glenoid component (arrows). At the time of operative revision, this thin layer of cement was seen to be cracked.

Opinions vary among surgeons regarding the advisability of placing cement between the body of the component and the prepared glenoid bone surface^{37,38}. On one hand, the grouting effect of cement can increase the quality of contact between the component and bone by filling in small voids. On the other hand, interposing cement between the back of the component and the bone presents a risk because a thin layer of cement is brittle and highly susceptible to fatigue, fracture, and displacement^{37,39-41}. The risk of cement fatigue may be increased by the admixture of antibiotics and by preparation methods that introduce porosity into the cement⁴². Failure of the cement interposed between the back of the component and the bone surface results in loss of seating and support for the component (Fig. 6).

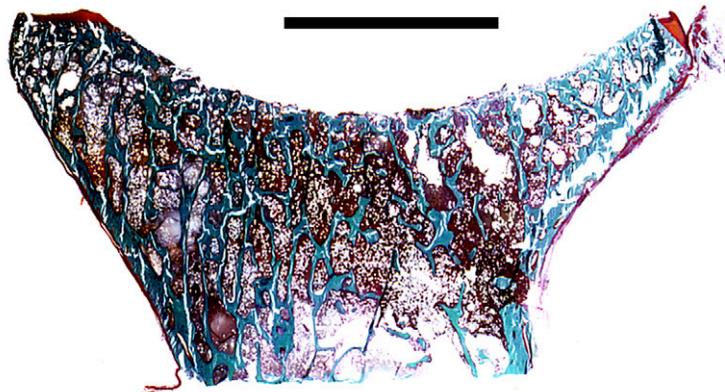
Fig. 7

Trabeculae exposed at the reamed surface of the glenoid bone may be damaged by the heat of reaming or by a lack of circulation to the surface. This freshly reamed canine glenoid was bisected through the shorter axis of its oval articular surface and in the plane normal to the surface and then was embedded in methylmethacrylate without decalcification. Ten-micrometer-thick sections were cut parallel to the sawn surface with use of a sledge microtome (model SM 2500; Leica, Wetzlar, Germany), thus providing a transverse cross section of the glenoid concavity and its underlying osseous architecture. The sections were stained with Goldner modified trichrome. Bone is stained teal blue while the marrow contents are stained dark red. The horizontal line indicates 1 cm.

ever, reaming may heat and disrupt the circulation to the surface of the glenoid bone, leading to a zone of necrosis, resorption, and loss of surface support of the prosthetic component (Fig. 7).

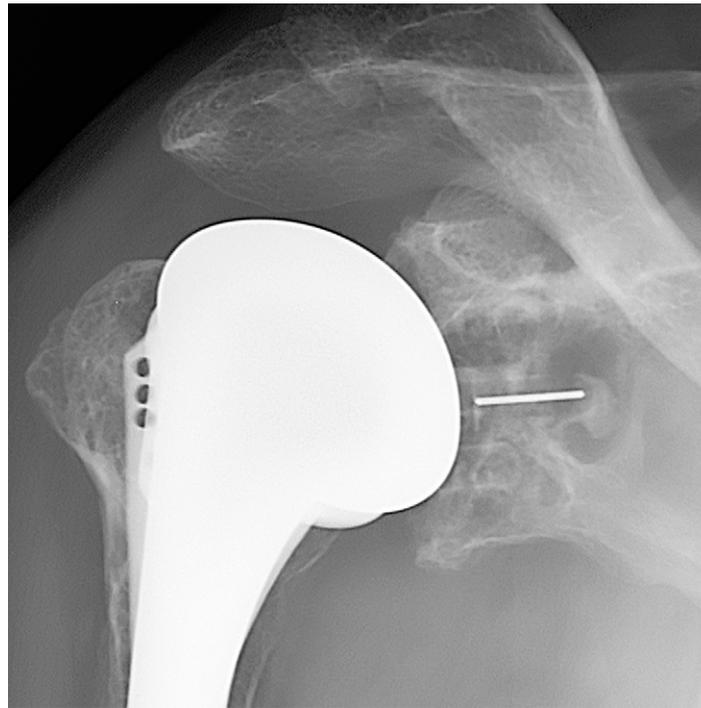
Fig. 8

The osteolytic bone resorption shown in this radiograph is much greater than the bone resorption seen with mechanical loosening alone. Pathologic and bacteriologic testing showed no evidence of infection but did reveal a massive chronic inflammatory reaction with small intracellular particles of polyethylene on polarized microscopy.

Minute particles, especially those of polyethylene, can lead to progressive resorption of bone and consequently to prosthetic failure⁷⁷ (Fig. 8). Particles of $<1 \mu\text{m}$ in size are taken in by monocytes, macrophages, and osteoblasts, which then activate osteoclastic bone resorption by means of the receptor/activator of nuclear factor-kappa B (NF- κB) (RANK)/receptor/activator of NF- κB ligand (RANKL) mechanism as well as the prostaglandin E₂, tumor necrosis factor-alpha, interleukin-1, and interleukin-6 mechanisms^{73,78-84}. Fibroblasts may also respond to particulate debris and express proinflammatory cytokines and RANKL, stimulating osteoclastogenesis and bone resorption⁸⁵. These events are much more common in the hip, in which the risk of osteolysis is related to the rate of polyethylene wear^{86,87}. As a possible explanation of this difference in prevalence, Wirth et al.⁸⁸ demonstrated that the polyethylene debris particles seen after shoulder arthroplasty are larger and less spherical than those seen after total hip arthroplasty. These larger particles may be less ingestible and thus less provocative of osteoclast activation.

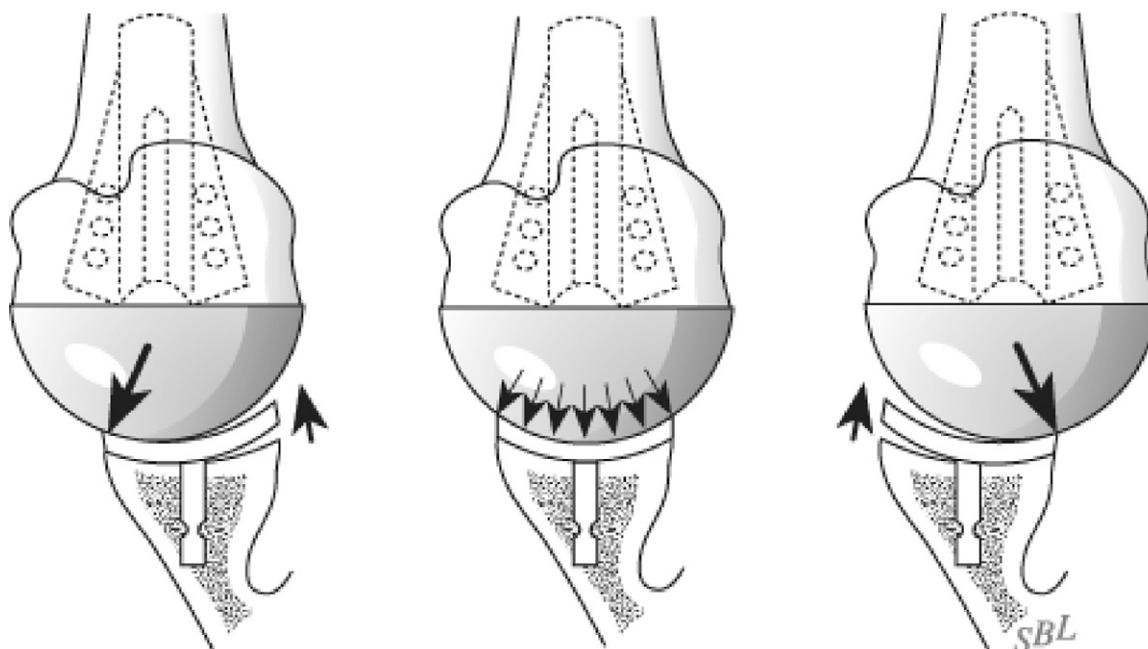
Fig. 9

Rocking-horse loosening. Although the glenoid component is stable when the load applied by the humeral head is centered (middle figure), anterior (left) or posterior (right) translation of the head of the glenoid causes eccentric loading and lifting up of the opposite, unloaded glenoid rim. (Reproduced, with modification, from: Matsen FA 3rd, Lippitt SB. *Shoulder surgery: principles and procedures*. Philadelphia: Saunders; 2004. Principles of glenoid arthroplasty; p 508. Reprinted with permission.)

Component malposition can give rise to the rocking-horse loosening mechanism, in which loading of one edge of the glenoid component causes the opposite edge to lift off of the glenoid bone (Fig. 9)^{31,33,54}. Inferior placement of the glenoid component and/or superior placement of the humeral component are common causes for this phenomenon (Fig. 10).

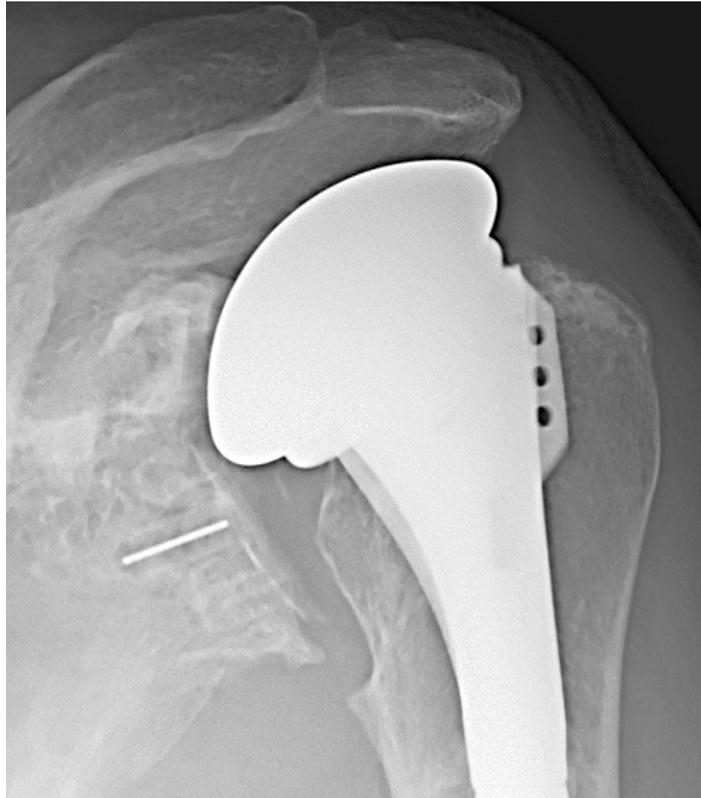
Fig. 10
Poor register of the humeral and glenoid components. The humeral component has been placed too high and the glenoid component, too low. The resulting eccentric loading has caused rocking-horse loosening of the glenoid component.
